**Capital Safety**
95 Derby Street
Silverwater, NSW
2128

# INSPECTION NOTICE

## PROTECTA REBEL SRL

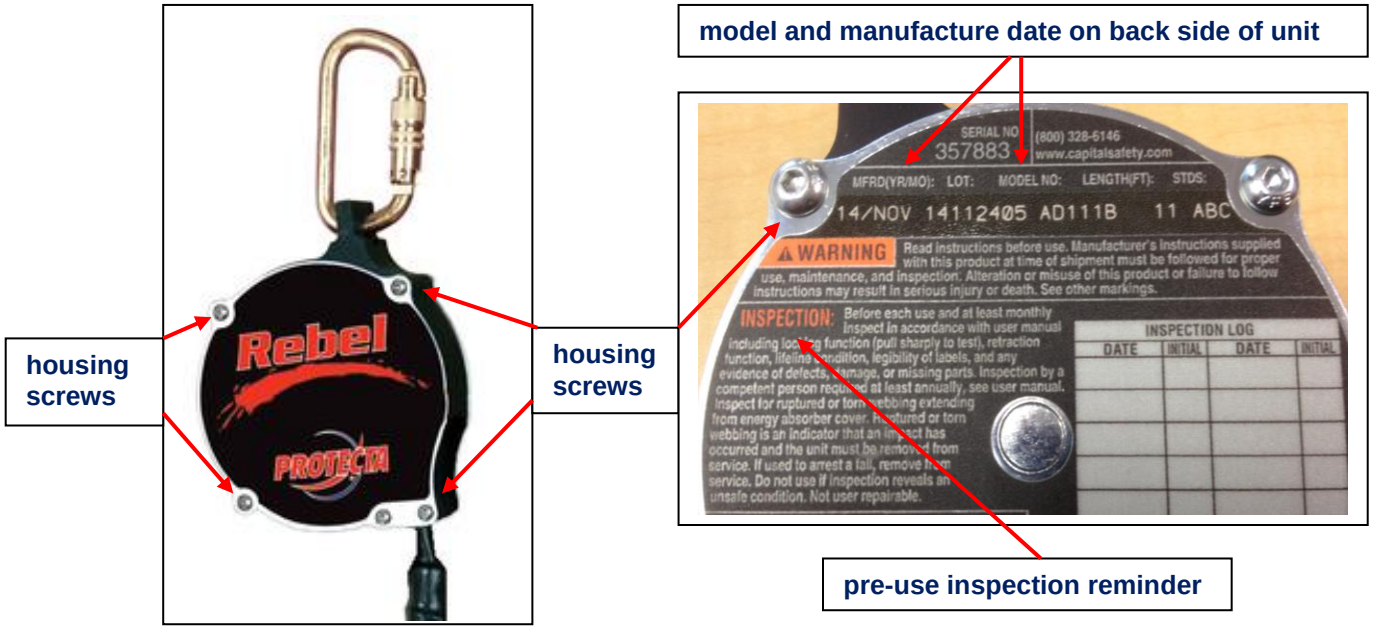
Capital Safety has learned of broken screw heads found in a limited number of Protecta brand Rebel Self-Retracting Lifelines (SRLs). The units affected by this notice are the black, extruded aluminum housing versions of the Rebel, manufactured between 1 April 2014 and 30 November 2014. (See photograph below.) The affected models are:

Although these units passed final assembly inspection by Capital Safety, reports indicate that the heads of some housing screws have been found broken off by end-users. These units have a total of ten externally visible screws that attach the two exterior housing plates to the main housing (five screws on each side, front and back).

Only the Protecta Rebel SRL models identified above are affected by this notice, and only those units manufactured between 1 April 2014 and 30 November 2014. Although we are confident this issue is limited to a select manufacturing lot of screws supplied by our vendor, we have taken the precaution of changing the type of screws used in these units to eliminate any potential of the condition reported.

b) if any housing screw heads are missing or broken, take the unit out of service;
c) if no housing screw heads are missing or broken, the units are safe to remain in service.

What to do if any Rebel SRL manufactured between 1 April 2014 and 30 November 2014 is found with a broken or missing housing screw head: The SRL should be removed from service and returned via distribution to Capital Safety, or users can call our Customer Service department directly at +61 (2) 8753 7600 to arrange to return their unit.
